APPENDIX A

Individual Site Descriptions and Rankings

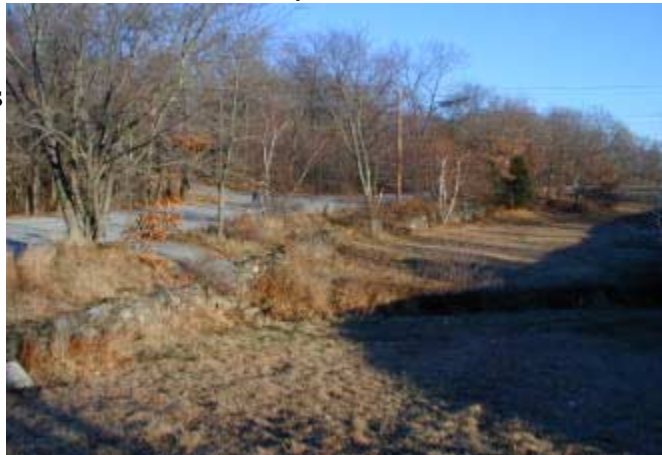
Site #G01 Cutler Brook at Jug Handle (Farnum Rd./Rt. 44) **Glocester**

Site Description: This site is located on the north side of Route 44 at the intersection with Farnum Road. Farnum Road splits and forms a “jug handle” before it merges with Route 44 and the site is within this jug handle. At nearly 600 feet in elevation, this site is truly in the upper portion of the watershed, about one mile upstream of where Cutler Brook enters Waterman Reservoir, and several miles from the River. Cutler Brook bisects the site, entering and leaving the site through culverts. The upstream culvert is surrounded by sloping pavement that directs untreated runoff directly into the brook. Upstream and downstream of the site Cutler Brook has a high degree of ecological integrity as it meanders through mature forest. As it flows through the site, however, the vegetation on both sides is cut right to the edge, and the topography grades gently and smoothly to the stream. Therefore, there is no topographic complexity and stormwater from the surrounding roads is allowed to easily reach the stream by overland flows and is not encouraged to infiltrate the soils. Most of the runoff to this section of

Restoration Opportunities: The low-cost restoration opportunity involves stopping mowing and letting the buffer revert to an unmanaged forested riparian buffer. Plantings could be used to jump-start the reversion to forest and to prevent a dominance of exotic/invasives. The more intensive restoration approach would be to re-grade the buffer to enhance infiltration, accommodate stormwater runoff, and create diverse micro-habitat.

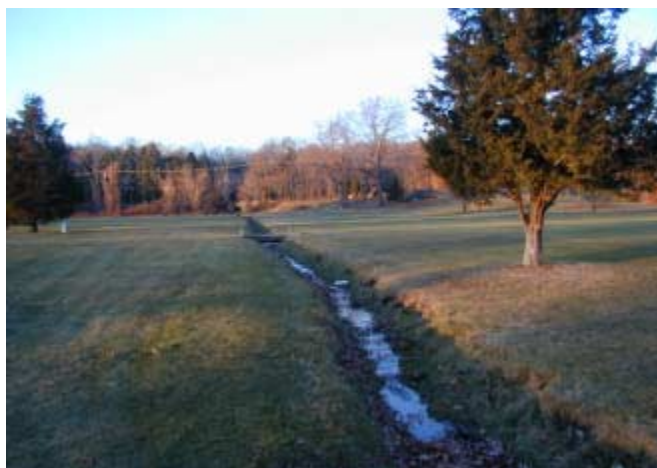
Site #G02 Glocester Country Club (Melody Hill Golf Course) **Glocester**

Site Information: This site consists of a small, channelized stream that bisects the golf course and is tributary to Waterman Reservoir. This portion of the golf course is in between

Restoration Opportunities: The low-cost restoration opportunity involves stopping mowing and letting the buffer revert to an unmanaged forested riparian buffer. Plantings would be used to jump-start the reversion to forest and to prevent a dominance of exotic/invasives. Such a forested buffer should be at least 25 feet wide but could be wider where the golf course function would not be compromised. Some sections, such as where the golf cart path crosses over the stream would remain clear. The more intensive restoration approach would be to re-grade the buffer to enhance infiltration, accommodate stormwater runoff, and create diverse micro-habitat. Water quality and wildlife habitat functions could also be greatly enhanced by modifying the existing channel and re-grading the site to allow for a more natural, meandering stream channel with natural (e.g., gravel) substrate and small floodplain areas.

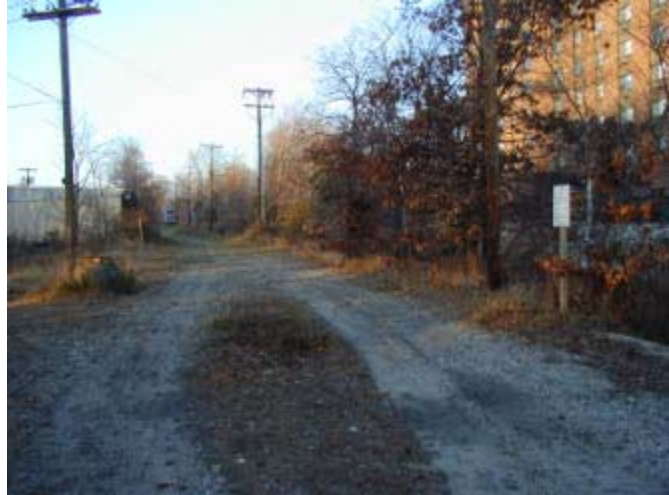
Site #J01 Easement near Putnam Pike (Rt. 44)
Johnston

Site Information: This site is a north-south oriented utility easement or right-of-way (ROW) on the west bank of the River immediately south of Route 44 and east of a series of parallel residential streets (including Swan Street) off Route 128. It is directly across the River from Centredale Manor (site #N02). The ROW is separated from the river by a very narrow (less than 10 feet) buffer situated on an abrupt/steep 3- to 4-foot bank. There are unvegetated portions of the utility easement resulting from vehicle, bike, and pedestrian traffic. No significant erosion was noted, partly because the easement is very flat. Japanese knotweed is the primary exotic/invasive species present on this site. Immediately landward (west) from the ROW there is a strip of forest on a steep hillside with some very small forested wetlands at the base of the hill next to the easement. The contributing drainage area to the west of this wooded hillside is moderate to high-density residential. The wooded hillside is able to accommodate the stormwater runoff it receives from above without significant erosion or concentrated surface flows. However, there is river flooding at the elevation of the easement according to those who nominated this site as a restoration opportunity. Such overbank flows are mostly independent of the vegetation condition on this site, and are related more to floodwater storage and de-synchronization upstream in the watershed.

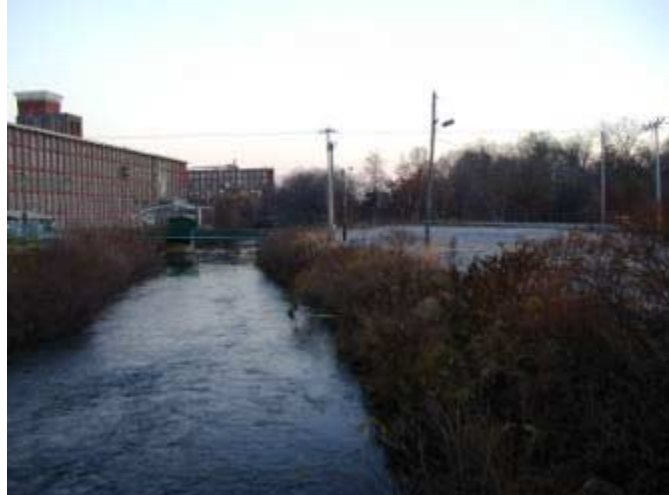
Site #J02 Greystone Mill Parking
Johnston

Restoration Opportunities: The restoration opportunity is to remove the existing parking lot, add topographic complexity (to encourage infiltration, and create heterogeneous habitat), and install native buffer plantings. The restoration would also involve soil amendments and removal of Japanese knotweed. This site was identified by URI/RI DEM during a wetland restoration study (Miller and Golet, 2000) as a potential restoration site (URI Site #214) because it was thought to be fill material to the River's edge and seemed to be unused.

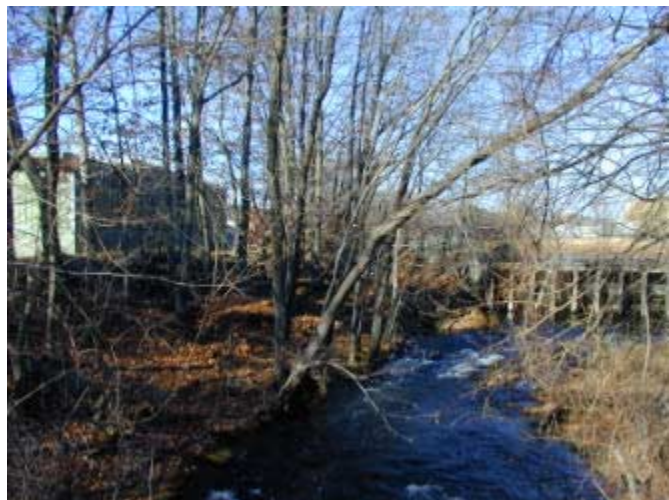
Site #J04 *Libutti Sand and Gravel (100 Allendale Ave.)*
Johnston

Restoration Opportunities: The restoration opportunity would be to establish a wooded riparian forested buffer by ceasing sand and gravel mining operations in the area closest to the River (perhaps within about 50 feet). Prior to installing native buffer plantings, it would be necessary to add a layer of topsoil to the site. A more elaborate restoration would also include grading to add topographic complexity to encourage infiltration and enhance habitat diversity. This site was identified by URI/RI DEM during a wetland restoration study (Miller and Golet, 2000) as a potential restoration site (URI Site #131) due to devegetation associated with the active business.

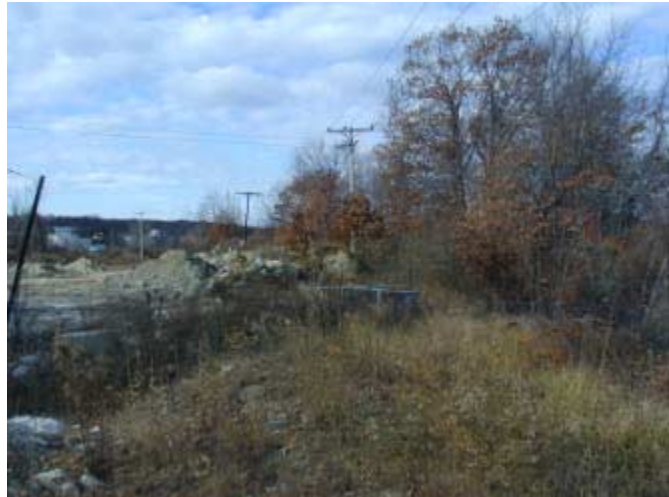
Site #J05 <i>New England Sand and Gravel (100</i>
	<u>Option #1</u> <i>Armento St.)</i> <u>Option #2</u>
	<u>Johnston</u>
Cost	Low
Benefit/Cost Ratio	Moderately high
Risk of Failure	Very low
	Site Information: This site is an active sand and gravel pit and asphalt plant on an area of glacial outwash

(USDA, 1981) along the west bank of Lyman's Mill Pond. There is a narrow (about 1 to 2 mature tree widths, or about 10 to 25 feet) buffer at the immediate River bank, but most remaining portions of the site lack vegetation. Exotic/invasive species along the bank include common reed (Phragmites), and Asiatic bittersweet. There is an extensive emergent marsh wetland in the impoundment just upstream of the site. Large piles of sand, gravel, and asphalt are interspersed with buildings and equipment, including cement mixers. Remaining areas are mostly exposed sand at grade. Because sand/gravel is rapidly permeable (excessively drained), it does not hold and store water the way a vegetated system with topsoil would or the way a more fine-textured soil would. Such areas can therefore be "leaky" with regard to nutrients and other pollutants, and reforestation efforts can mitigate this. The River bank is steep in places, but appeared to be generally stable. We spoke with a manager, who indicated that one cement mixing structure and associated equipment near the river was going to be relocated in the near future.

Restoration Opportunities: This area could be reclaimed as forested buffer if the landowner(s) are interested. The restoration opportunity is to establish a riparian forested buffer by ceasing sand and gravel mining operations in the area closest to the River (perhaps within about 50 feet). Prior to installing native buffer plantings, it would be necessary to add a layer of topsoil to the site. A more elaborate restoration would also include grading to add topographic complexity to encourage infiltration and enhance habitat diversity. Grading coarse-textured outwash material is typically easy/rapid as compared to other

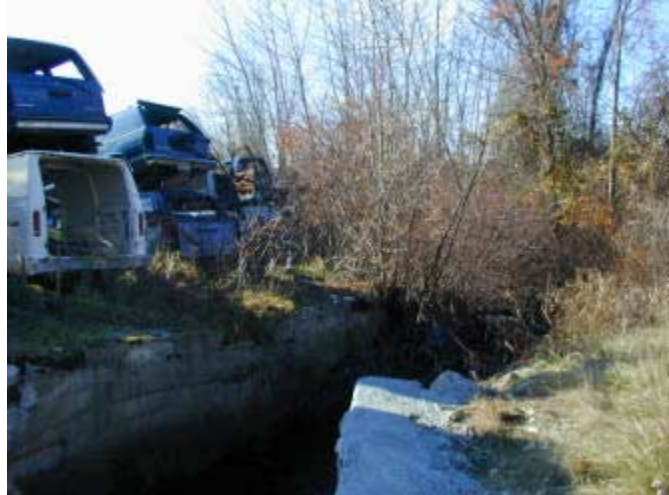
Site #J06 Johnston Auto Salvage
Johnston

Site Information: This site is an active auto salvage yard on an area of glacial outwash (USDA, 1981) along the west bank of Lyman's Mill Pond. There is a fairly wide (about 100 feet) buffer at the immediate River bank, but most remaining portions of the site lack vegetation and are covered with piles of cars or exposed and disturbed soils. A small perennial stream that is directly tributary to the River approximates the northern extent of the salvage yard. This stream is inadequately buffered in several places, including near the northeast corner of the site, where cars are piled up to the stream edge and the stream is channelized. Exotic/invasive species along the bank include Morrow's honeysuckle, Japanese knotweed, and Asiatic bittersweet. There is a relatively undisturbed wetland associated with the tributary stream between the River and the northeast corner of the site. Some portions of the yard are cleared of cars, but are also devoid of vegetation. Because the yard is located on rapidly permeable soils (coarse-textured outwash), the site is likely "leaky" with regard to nutrients and other pollutants, and reforestation efforts can mitigate this. Such soils do not hold and store water without vegetation, the way a vegetated system with topsoil would or the way a more fine-textured or less permeable soil (such as tills) would. All or part of this site could be reclaimed as forested buffer if the landowner(s) are interested. The priority should be the northern part of the yard adjacent to the tributary stream and the eastern part of the yard near the River.

Restoration Opportunities: The restoration opportunity is to establish a wooded riparian buffer. Prior to installing native buffer plantings, it would be necessary to add a layer of topsoil to the site. A more elaborate restoration would also include grading to add topographic complexity to encourage infiltration and enhance habitat diversity. Grading coarse-textured outwash material is typically easy/rapid as compared to other surficial materials such as tills. This site was identified by URI/RI DEM during a wetland restoration study (Miller and Golet, 2000) as a potential restoration site (URI Site #53) due to devegetation associated with the active business.

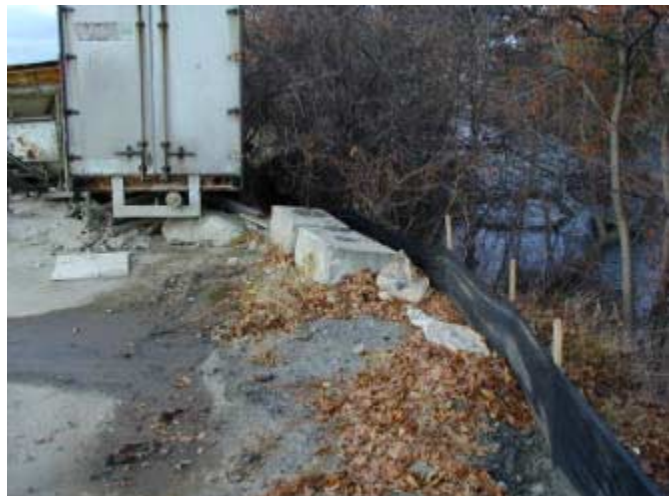
Site #J07 *Pezza Sand and Gravel (100 Irons Ave.)*
Johnston

Restoration Opportunities: The restoration opportunity is to establish a wooded riparian buffer by ceasing sand and gravel mining operations in the area closest to the River (perhaps within about 50 feet). Prior to installing native buffer plantings, it would be necessary to add a layer of topsoil to the site. A more elaborate restoration would also include grading to add topographic complexity to encourage infiltration and enhance habitat diversity. Grading coarse-textured outwash material is typically easy/rapid as compared to other surficial materials such as tills. This site was identified by URI/RI DEM during a wetland restoration study (Miller and Golet, 2000) as a potential restoration site (URI Site #83) due to devegetation associated with the active business.

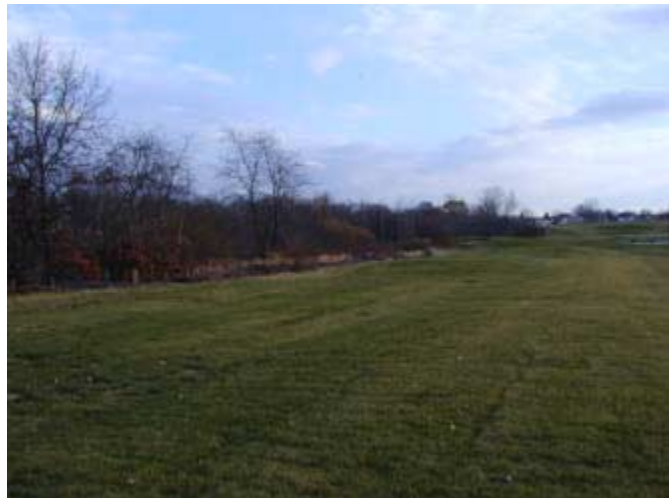
Site #J08 *Dyerville Park Golf Course*
Johnston

Restoration Opportunities: The low-cost restoration opportunity involves stopping mowing in selected sections of the eastern edge of the existing golf course grounds and letting the buffer revert to an unmanaged forested riparian buffer, subject to landowner interest. Plantings would be used to jump-start the reversion to forest and to ensure that desirable native species are favored. Ideally, a continuous buffer with a minimum width of 100 feet would be established. The more intensive restoration approach is to re-grade the buffer to enhance infiltration and accommodate stormwater runoff from the golf course. This would also create topographic complexity for habitat diversity. A vegetated infiltration basin could be installed at the base of the existing riprap drainage swale at the northern end of the park.

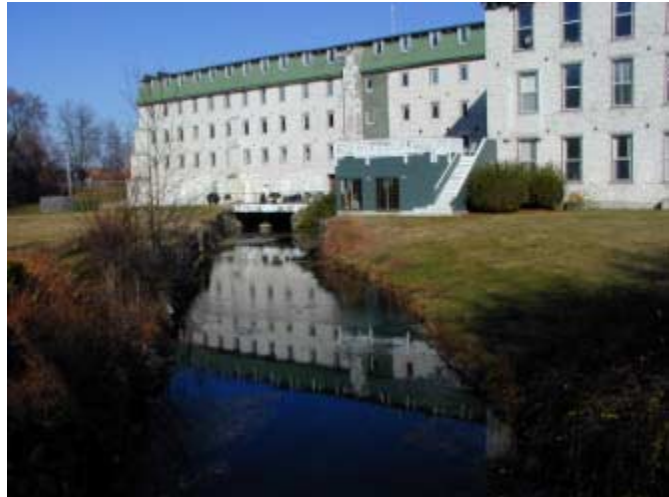
Site #N01 *Allendale Mill*
North Providence

Restoration Opportunities: The low-cost restoration opportunity involves stopping mowing in selected sections of the existing lawn and letting the buffer revert to an unmanaged forested riparian buffer. Plantings would be used to jump-start the reversion to forest and to ensure that desirable native species are favored. The more intensive restoration approach is to re-grade the buffer to enhance infiltration, accommodate stormwater runoff, and create diverse micro-habitat. Water quality and wildlife habitat functions could also be greatly enhanced by removing the existing channel and re-grading the site to allow for a more natural, meandering stream channel with natural substrate and small floodplain areas. Alternatively, portions of the channel could be filled to create wetland basins that would trap sediments and remove nutrients from stormwater, and discourage inadequately polished runoff from reaching the River via overland flows. This site is part of a Superfund site, which creates both potential constraints (e.g., site contamination issues), and opportunities (e.g., partnering).

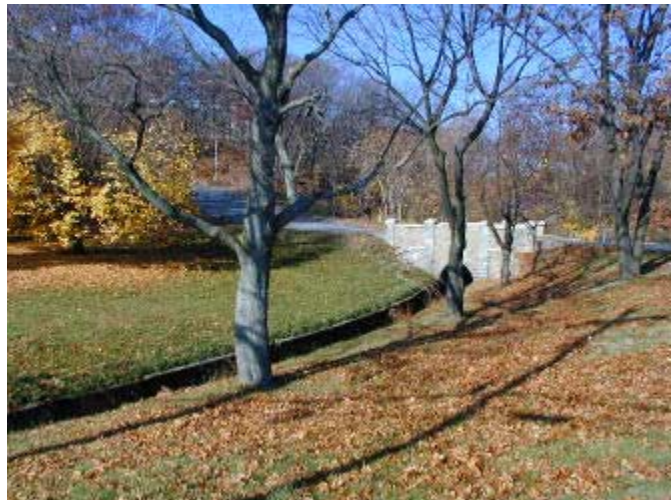
Site #P01 *Pleasant Valley Creek/VA Med. Center*
Providence

Restoration Opportunities: The low-cost restoration opportunity involves stopping mowing and letting the buffer revert to an unmanaged forested riparian buffer. Plantings could be used to jump-start the reversion to forest and to prevent a dominance of Norway maple, since this exotic/invasive already dominates the woody vegetation on the site. The more intensive restoration approach would be to re-grade the buffer to enhance infiltration, accommodate stormwater runoff, and create diverse micro-habitat. Water quality and wildlife habitat functions could also be greatly enhanced by removing the existing channel and re-grading the site to allow for a more natural, meandering stream channel with natural (*e.g.*, gravel) substrate and small floodplain areas.

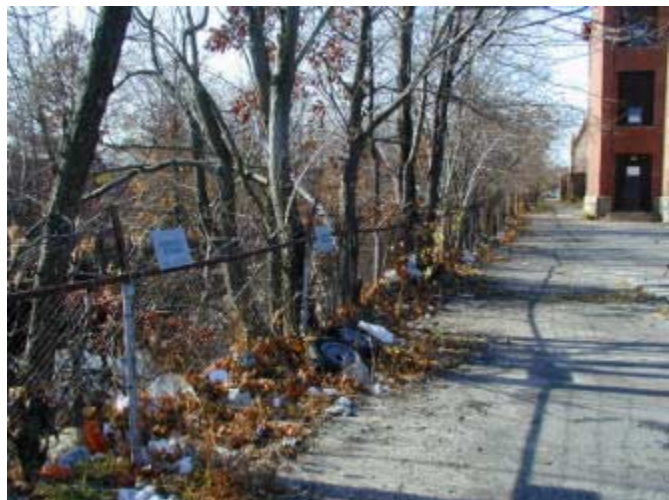
Site #P02 68 Hemlock St.
Providence

Site Information: The majority of this urban lot is impervious surface (*i.e.*, parking and old industrial buildings). A vertical stone retaining wall that is unstable and beginning to fail separates the parking lot from the river. A very narrow (one tree width) wooded buffer has become established in the interstices of the retaining wall and there is a small patch of grass and weeds in the southeast corner of the site. All runoff from the impervious surfaces on this site drains directly into storm drains that discharge directly to the river without being treated by the soil/root zone of a naturally vegetated buffer. The site is bounded by the river to the south and by urban development (roads, commercial/industrial) to the north, east, and west. Exotic/invasives growing along the narrow buffer include Japanese knotweed and Norway maple. There appears to be an old storage tank beneath the parking area near the river.

Restoration Opportunities: There are no low-cost restoration opportunities. The restoration opportunity is to remove existing impervious surfaces, remove the retaining wall, feather back the soils behind the retaining wall (to re-establish a floodplain relationship between the river and the riparian buffer), add topographic complexity (to encourage infiltration, create habitat diversity, and accommodate and treat stormwater from the surrounding impervious surfaces), and install native buffer plantings. The restoration would also involve soil amendments and removal of Japanese knotweed and other exotics.

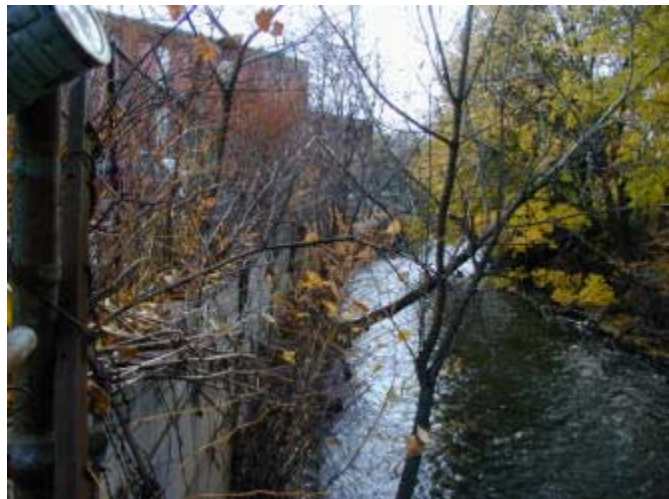
Site #P03 586 Atwells Ave.
Providence (Olneyville)

Restoration Opportunities: There are no low-cost restoration opportunities. The restoration opportunity is to remove existing impervious surfaces, remove the tall retaining wall, feather back the soils behind the retaining wall (to re-establish a closer relationship between the river and the riparian buffer), add topographic complexity (to encourage infiltration, enhance habitat diversity, and accommodate and treat stormwater from the surrounding impervious surfaces), and install native buffer plantings.

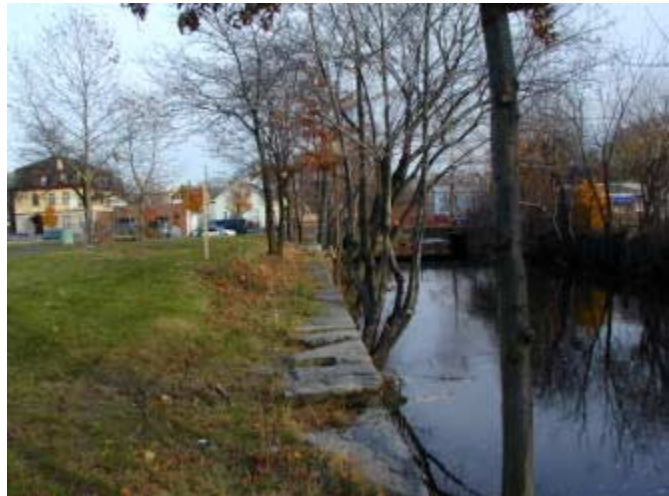
Site #P04 Donigian Park/Valley St. Playground
Providence (Olneyville)

Restoration Opportunities: The low-cost restoration opportunity would be to establish a wider riparian forested buffer by ceasing to mow immediately adjacent to the river, installing native vegetation, and completing some minor erosion control and soil amendments near the retaining wall. A more elaborate restoration would be to remove the retaining wall, feather back the soils behind the retaining wall (to re-establish a closer relationship between the river and the riparian buffer), add topographic complexity (to encourage infiltration, create habitat diversity, and accommodate and treat stormwater from the surrounding impervious surfaces), and install native buffer plantings.

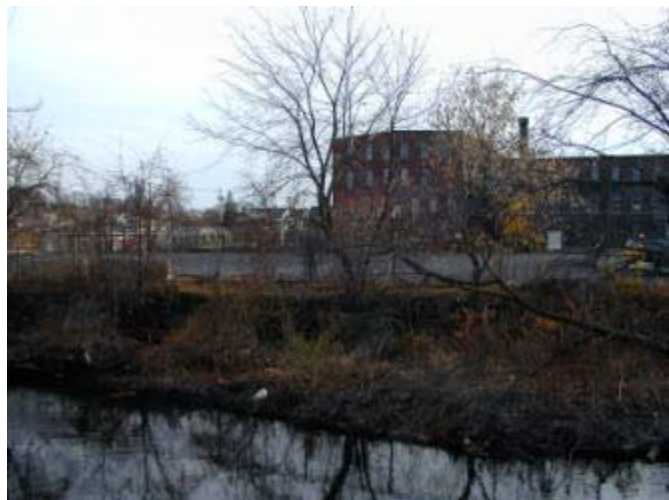
Site #P05 190 Valley St.
Providence (Olneyville)

Restoration Opportunities: There are no low-cost restoration opportunities. The restoration opportunity is to remove a portion of the existing impervious surfaces, remove the floodwall, grade the soils (to re-establish a closer relationship between the river and the riparian buffer), add topographic complexity (to encourage infiltration, enhance habitat diversity, and accommodate and treat stormwater from the surrounding impervious surfaces), and install native buffer plantings.

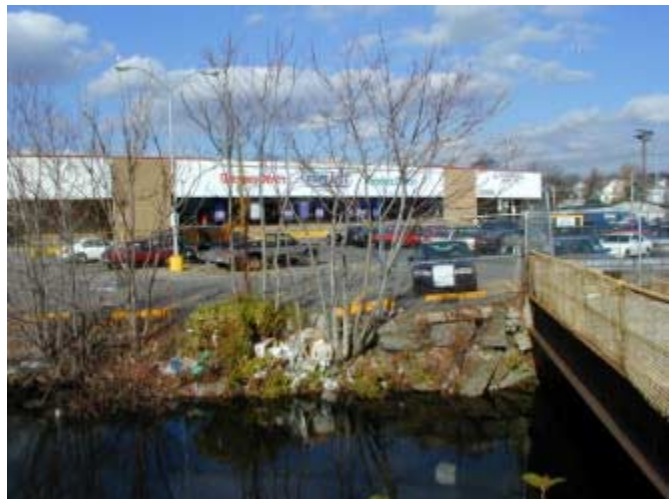
Site #P06 80 Manton Ave. (Shopping Center)
Providence (Olneyville)

Restoration Opportunities: The restoration opportunity is to remove existing impervious surfaces, remove the retaining wall, grade the soils behind the retaining wall (to re-establish a closer relationship between the river and the riparian buffer), add topographic complexity (to encourage infiltration, create habitat diversity, and accommodate and treat stormwater from the surrounding impervious surfaces), and install native buffer plantings. The restoration would also involve soil amendments and removal of Japanese knotweed.

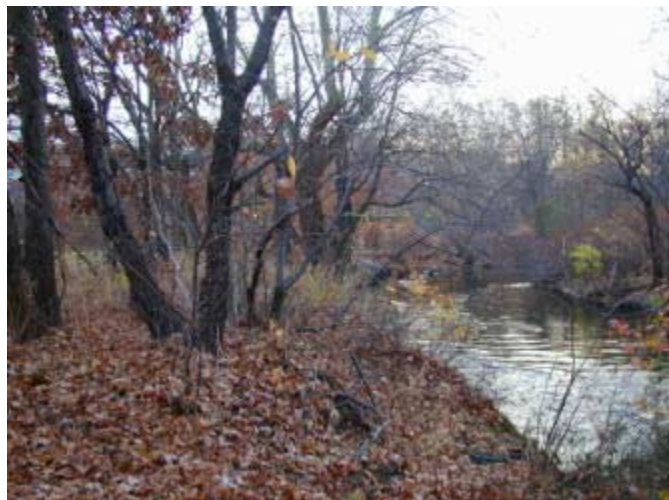
Site #P07 *Merino Park*
Providence (Hartford)

Restoration Opportunities: The low-cost restoration opportunity would be to establish a wider riparian forested buffer by ceasing to mow in the areas closest to the river, and installing native buffer plantings. A more elaborate restoration would also include stream bank stabilization over about a 30-foot long stretch of bank. One approach would be to construct a viewing deck (since foot traffic is inevitable) and do bio-stabilization along the remaining stretch. The more elaborate restoration could also include grading to add topographic complexity to encourage infiltration and enhance habitat diversity.

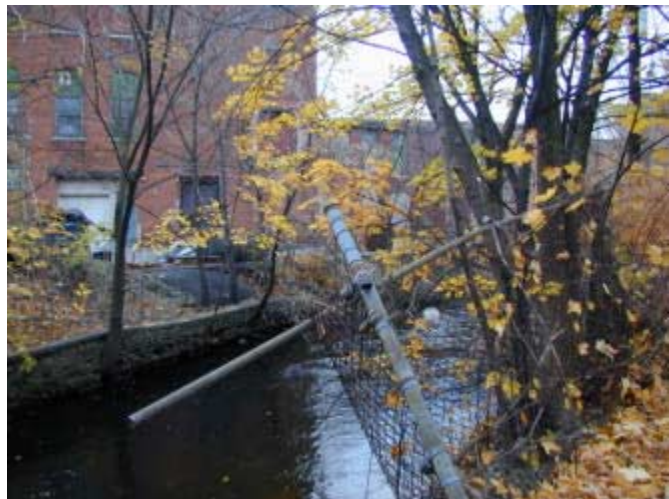
Site #P08 Eagle St./Atwells Ave./Valley St. Brownfield
Providence

Site Information: This urban lot, which straddles the River, consists of a complex of industrial mill buildings and parking areas and is virtually all impervious surface. This lot is currently the subject of a potential redevelopment project, and there is therefore some opportunity to improve the riparian buffer condition on the site relative to the present as a component of this project. Vertical stone and concrete retaining walls approximately 4 to 8 feet in height line the River. Water stains on these walls reveal that the River in this location is subject to tidal fluctuation. A very narrow (one mature tree width) wooded buffer has become established on top of the retaining wall. All runoff from the impervious surfaces on this site drains directly into storm drains that discharge directly to the river without being treated by the soil/root zone of a naturally vegetated buffer. The site is surrounded by roads and dense commercial and residential development. Exotic/invasives growing along the narrow buffer include Japanese knotweed, Asiatic bittersweet, and Norway maple.

Restoration Opportunities: The restoration opportunity would be to remove existing impervious surfaces immediately adjacent to the River, remove the tall retaining wall where possible, feather back the soils behind the retaining wall (to re-establish a closer relationship between the river and the riparian buffer) where possible, add topographic complexity (to encourage infiltration and create habitat diversity), and install native buffer plantings. The restoration would also involve soil amendments and removal of Japanese knotweed and other exotic/invasives.

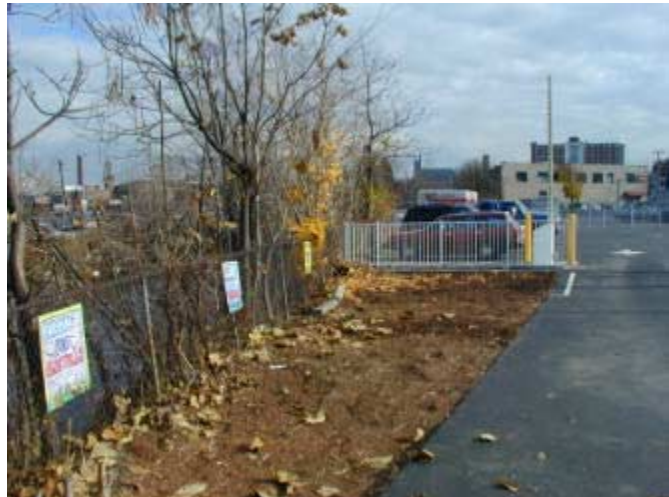
Site #P09 *Olneyville Post Office Parking*
Providence (Olneyville)

Restoration Opportunities: The restoration opportunity is to remove existing impervious surfaces, remove the retaining wall, grade the soils behind the retaining wall (to re-establish a closer floodplain relationship between the river and the riparian buffer), add topographic complexity (to encourage infiltration, create habitat diversity, and accommodate and treat stormwater from the surrounding impervious surfaces), and install native buffer plantings. The restoration would also involve soil amendments and removal of exotic/invasives.

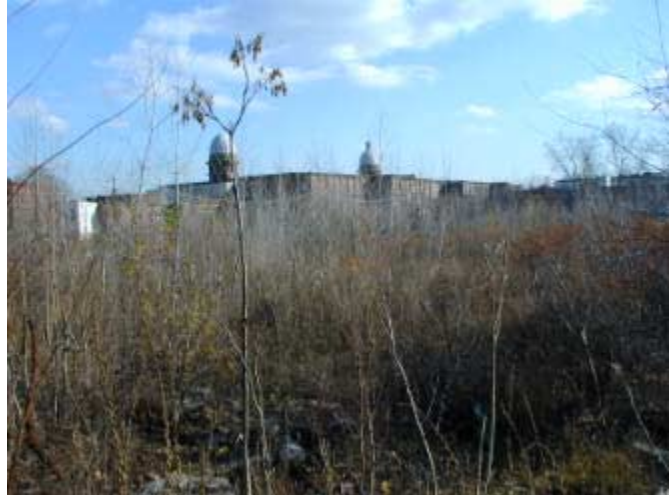
Site #P10 Riverside Mill (50 Aleppo St.)
Providence

Site Information: This city-owned lot is a former mill site off of Aleppo Street immediately upstream from Olneyville and downstream from Merino Park (site #P07). The existing condition features an early-successional community of plants typical of disturbed sites and abandoned urban lots. A large variety of exotic/invasive species have gained a foothold within this community, including common reed, purple loosestrife, Japanese knotweed, multiflora rose, tree-of-heaven, Norway maple, Asiatic bittersweet, Morrow's honeysuckle, mullein, and Russian olive. A diverse community of native vegetation is also present, however, including sweet pepperbush, black willow, blue vervain, and red maple at the stream margin, and several native upland grasses and forbs over the disturbed soils of the site's interior. Debris from historical uses occurs throughout the site, including concrete slabs, small piles of brick, and pieces of rusted metal. Dense residential development occupies the contributing drainage area upgradient from the site, to the north and east. There is a relatively small component of stormwater runoff from the residential area that does not enter city storm drains and which reaches the site. This runoff is able to infiltrate the soils on the site before reaching the River. No signs of concentrated surface runoff such as gullies, rivulets, or eroding soils were evident on the site. The site is almost entirely vegetated, but some areas are sparsely vegetated due to debris and sterile (*i.e.*, low organic matter) soils. There is an intact forested riparian buffer on the opposite side of the River from the site, to the south and west, that includes uplands, wetlands, and floodplains interspersed. There are also some narrow emergent and scrub-shrub wetlands along the river margin on both sides of the River.

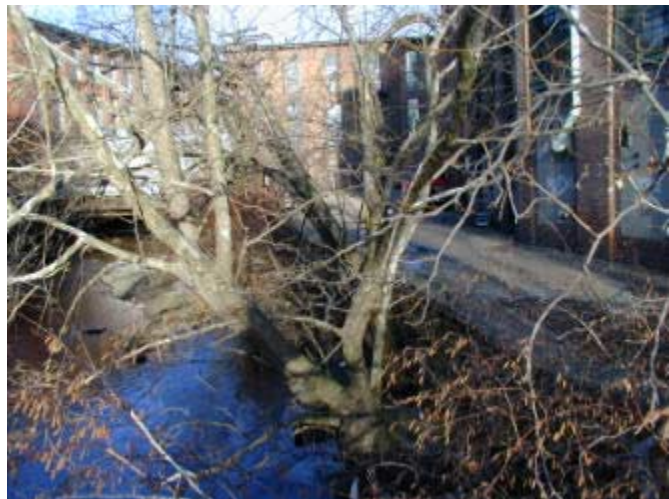
Site #P12 *Atlantic Mills (Manton Ave.)*
Providence

Restoration Opportunities: There are no low-cost restoration opportunities. The restoration opportunity is to remove existing impervious surfaces, remove the retaining wall, feather back the soils behind the retaining wall (to re-establish a floodplain relationship between the river and the riparian buffer), add topographic complexity (to encourage infiltration, create habitat diversity, and accommodate and treat stormwater from the surrounding impervious surfaces), and install native buffer plantings. The restoration would also involve soil amendments and removal of Japanese knotweed and other exotics.

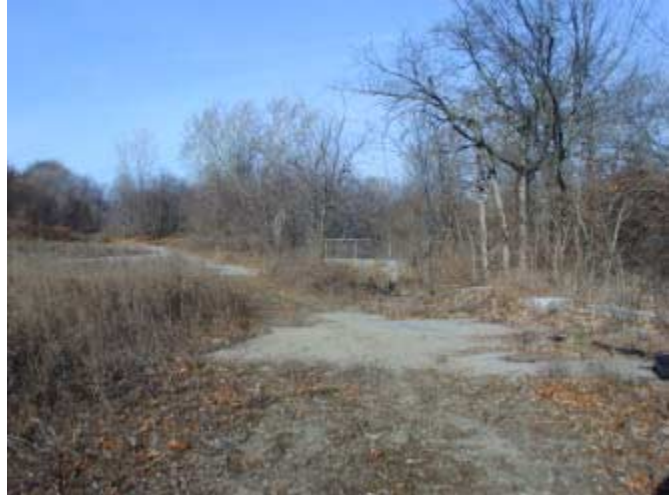
Site #P13 ***Lincoln Lace and Braid Brownfield (near Merino Park)***
Providence (Hartford)

Site Information: This is a former industrial site just upstream from Merino Park. The above-ground structures were removed in the very recent past. However, large concrete slabs, piles of gravel, and broken pavement still remain over the approximately 3 acres of open (non-forested) land. The existing condition features an early-successional community of plants typical of disturbed sites and abandoned urban lots. A few exotic/invasive species have gained a foothold within this community, including common reed, Japanese knotweed, tree-of-heaven, Norway maple, and mullein. A block of mature forest including both upland and wetland habitat types borders the site to the east and separates the site from Merino Park. There are also small (a few acres or less) blocks of contiguous riparian forest immediately to the west of the site and across the River to the north. As such, reforestation of the subject lot would create a significant contiguous block of riparian forest that would be large enough to provide habitat for interior bird species and other wildlife species that are sensitive to fragmentation, such as many herptiles. A diverse community of native vegetation is present in the wooded areas adjacent to this site, which would help in terms of a seed source for future re-vegetation. There is a section of vertical retaining wall along a large section of the River bank, which is as much as 8 feet tall. There is a densely populated residential and commercial area (subsection known as Hartford) to the south and southwest of the site. No signs of concentrated surface runoff such as gullies, rivulets, or eroding soils were evident on the site, but some degree of overland flows and shallow subsurface runoff from the developed contributing area can be assumed to be accommodated by the site. This runoff is able to infiltrate the soils on the site before reaching the River. The site is almost entirely vegetated, but some areas are sparsely vegetated due to debris and sterile (*i.e.*, low organic matter) soils. There is a bypass reach that flows around the south side of the site and re-enters the river near Merino Park.

Restoration Opportunities: The low-cost restoration opportunity involves simply letting the buffer revert to an unmanaged forested riparian buffer. Plantings could be used to jump-start the succession to forest and influence the ultimate species composition. Most of the existing exotic/invasive species are shade intolerant and would ultimately be shaded out as the site became forested. Soil amendments would be necessary in places and debris would need to be removed. The more intensive restoration approach would be to re-grade the buffer to enhance infiltration, accommodate stormwater runoff, and create micro-habitat diversity. The steep retaining wall could be removed, and the bank could be feathered back in some areas to create a more natural link between the River and the buffer, such as grading to allow forested floodplain to develop. Biostabilization measures and, if necessary, some structural components, would be used at the immediate bank. The close proximity to this site of housing projects and high-density residential areas increases the potential benefits in education and aesthetic buffer functions from a riparian buffer development project. The bypass reach could be used for wetland restoration since wetland hydrology is already present. This site is part of a former Superfund site, which creates both potential constraints (*e.g.*, site contamination issues), and opportunities (*e.g.*, partnering).
